**STUDY SUMMARY – WHITE PAPER**

**January 12, 2023**

**MD 97 (Georgia Avenue) High Injury Network Safety Study  
Recommendations Specific to Montgomery County DOT**

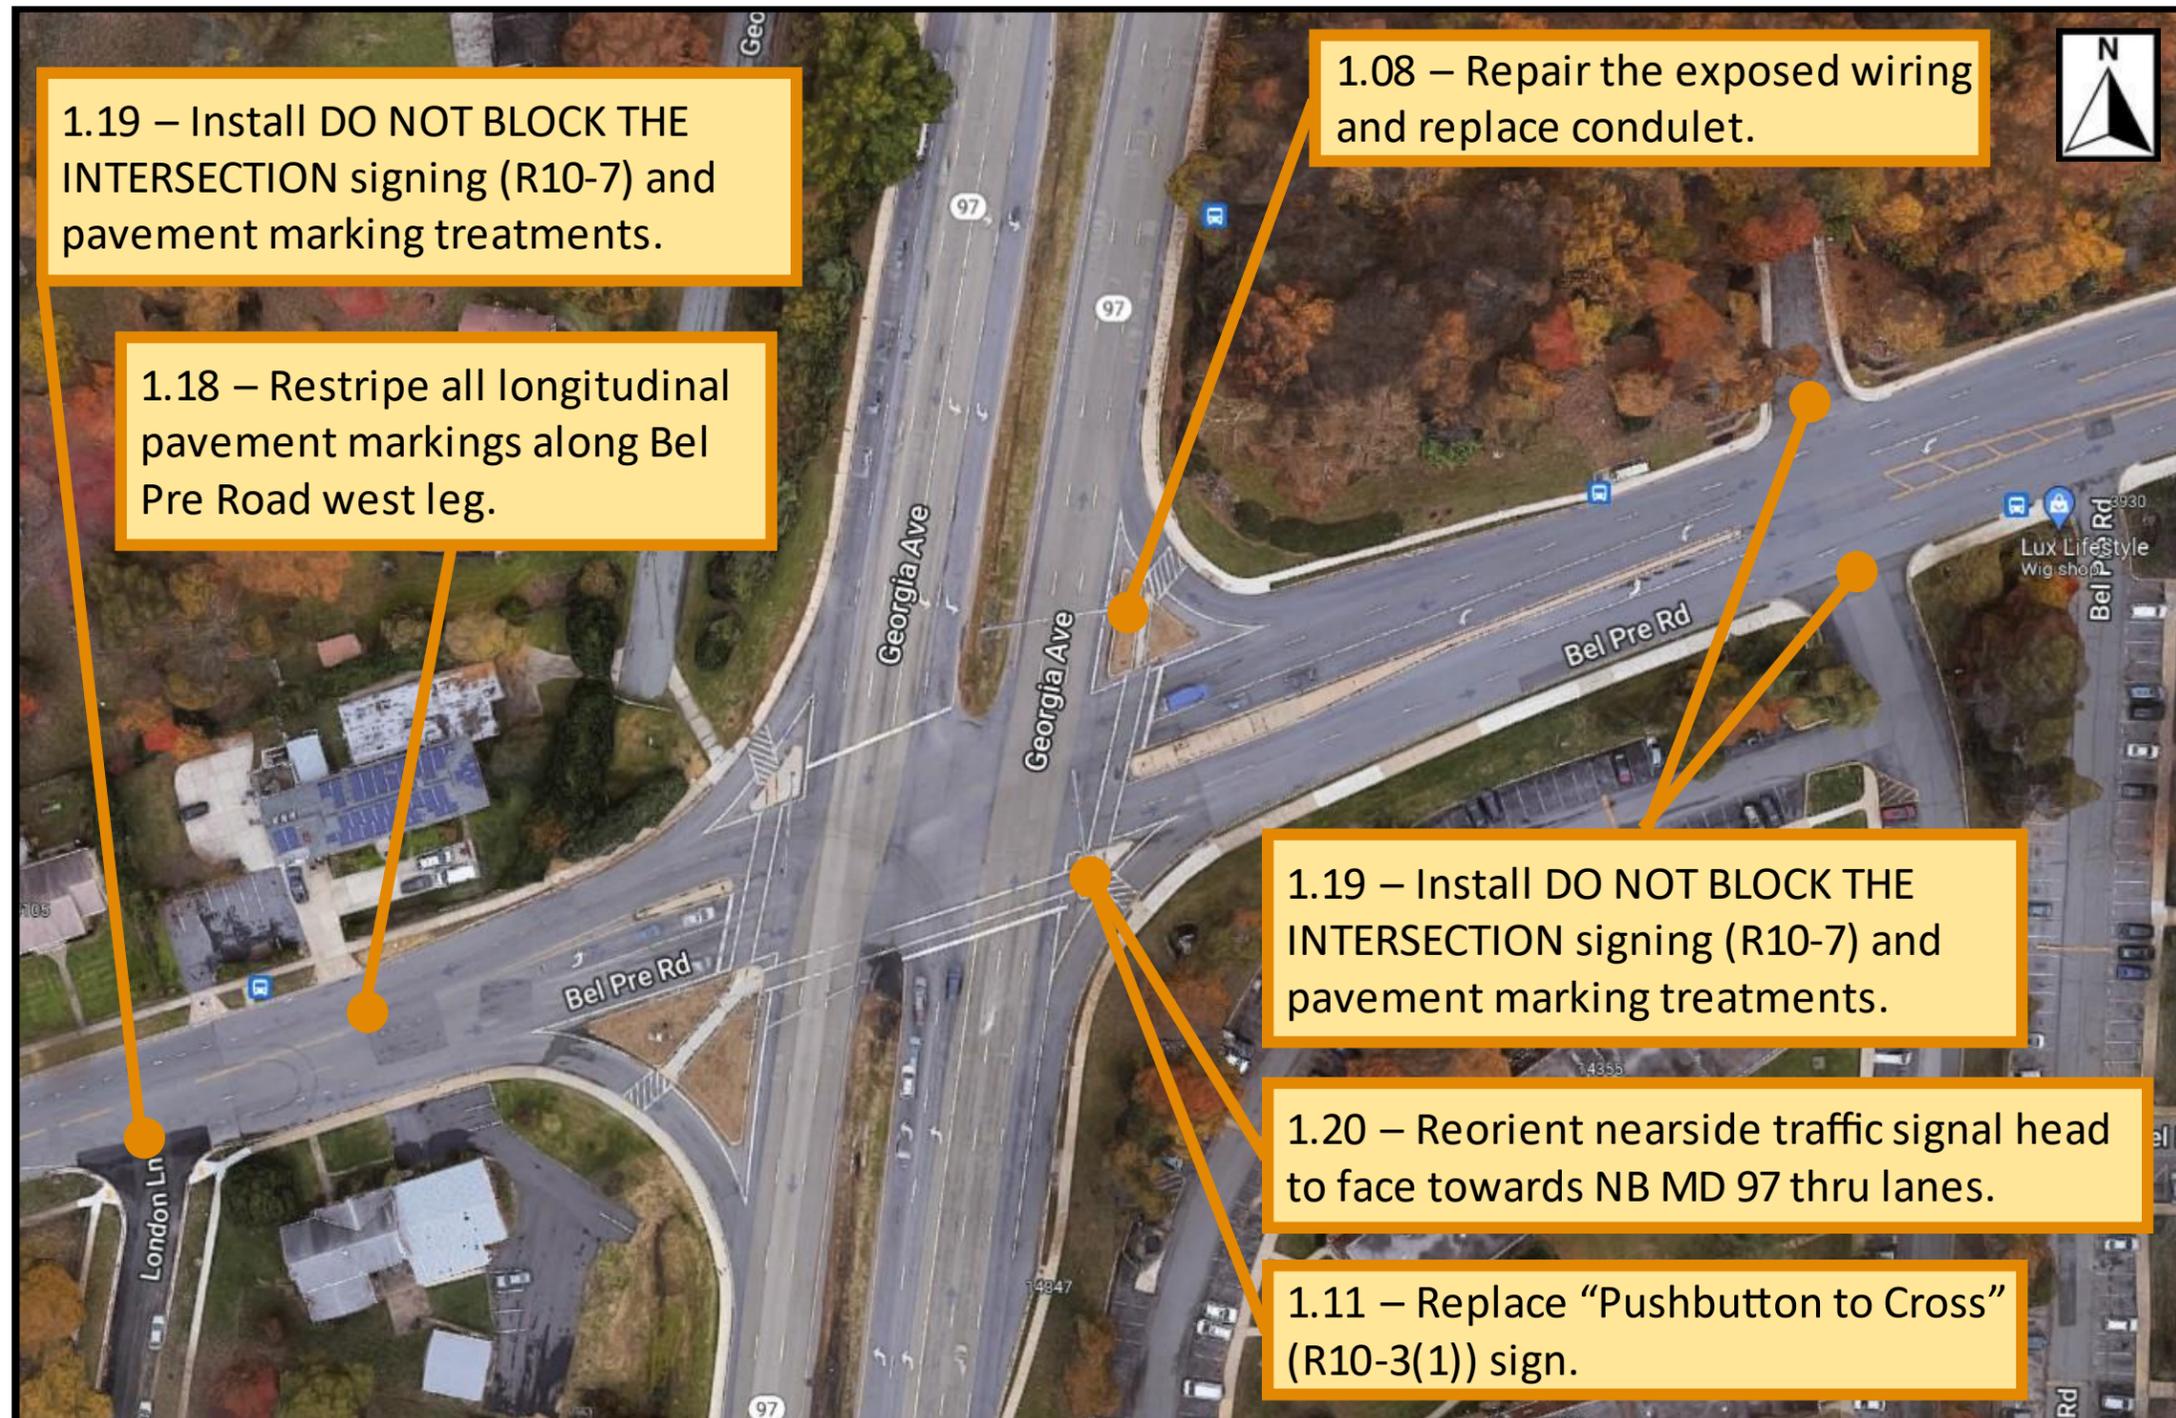
Figure 1: MCDOT – Specific Recommendations: MD 97 (Georgia Avenue) at Bel Pre Road

Issue No.	Safety Issue/Observations	Recommendation	Timeframe
Location 1: MD 97 (Georgia Avenue) at Bel Pre Road - Signalized Intersection			
1.08	Maintenance. Broken conduit for pole mounted enclosure.	Repair the exposed wiring on the signal mast arm in the northeast (NE) corner channelized island.	0 – 6 months

1.11	Maintenance. Pushbutton sign has the incorrect street name.	Replace "Pushbutton to Cross" (R10-3(1)) sign for south leg crossing MD 97 in the SE quadrant.	0 – 6 months

1.18	Maintenance. Pavement markings in poor condition.	Restripe all longitudinal pavement markings along Bel Pre Rd west leg.	0 – 6 months
1.19	Vehicular Operations. Queues along Bel Pre Road hinder access for driveways and side streets.	Install DO NOT BLOCK THE INTERSECTION signing (R10-7) and pavement marking treatments on Bel Pre Rd for the church and apartment driveways to the east, and London Lane to the west.	0 – 6 months

1.20	Maintenance. Nearside traffic signal head in SE curbed island is facing towards uncontrolled right turn lane.	Reorient traffic signal head to face towards NB MD 97 thru lanes.	0 – 6 months
Location 2: MD 97 (Georgia Avenue) between Bel Pre Road and Heathfield Road – Road Segment

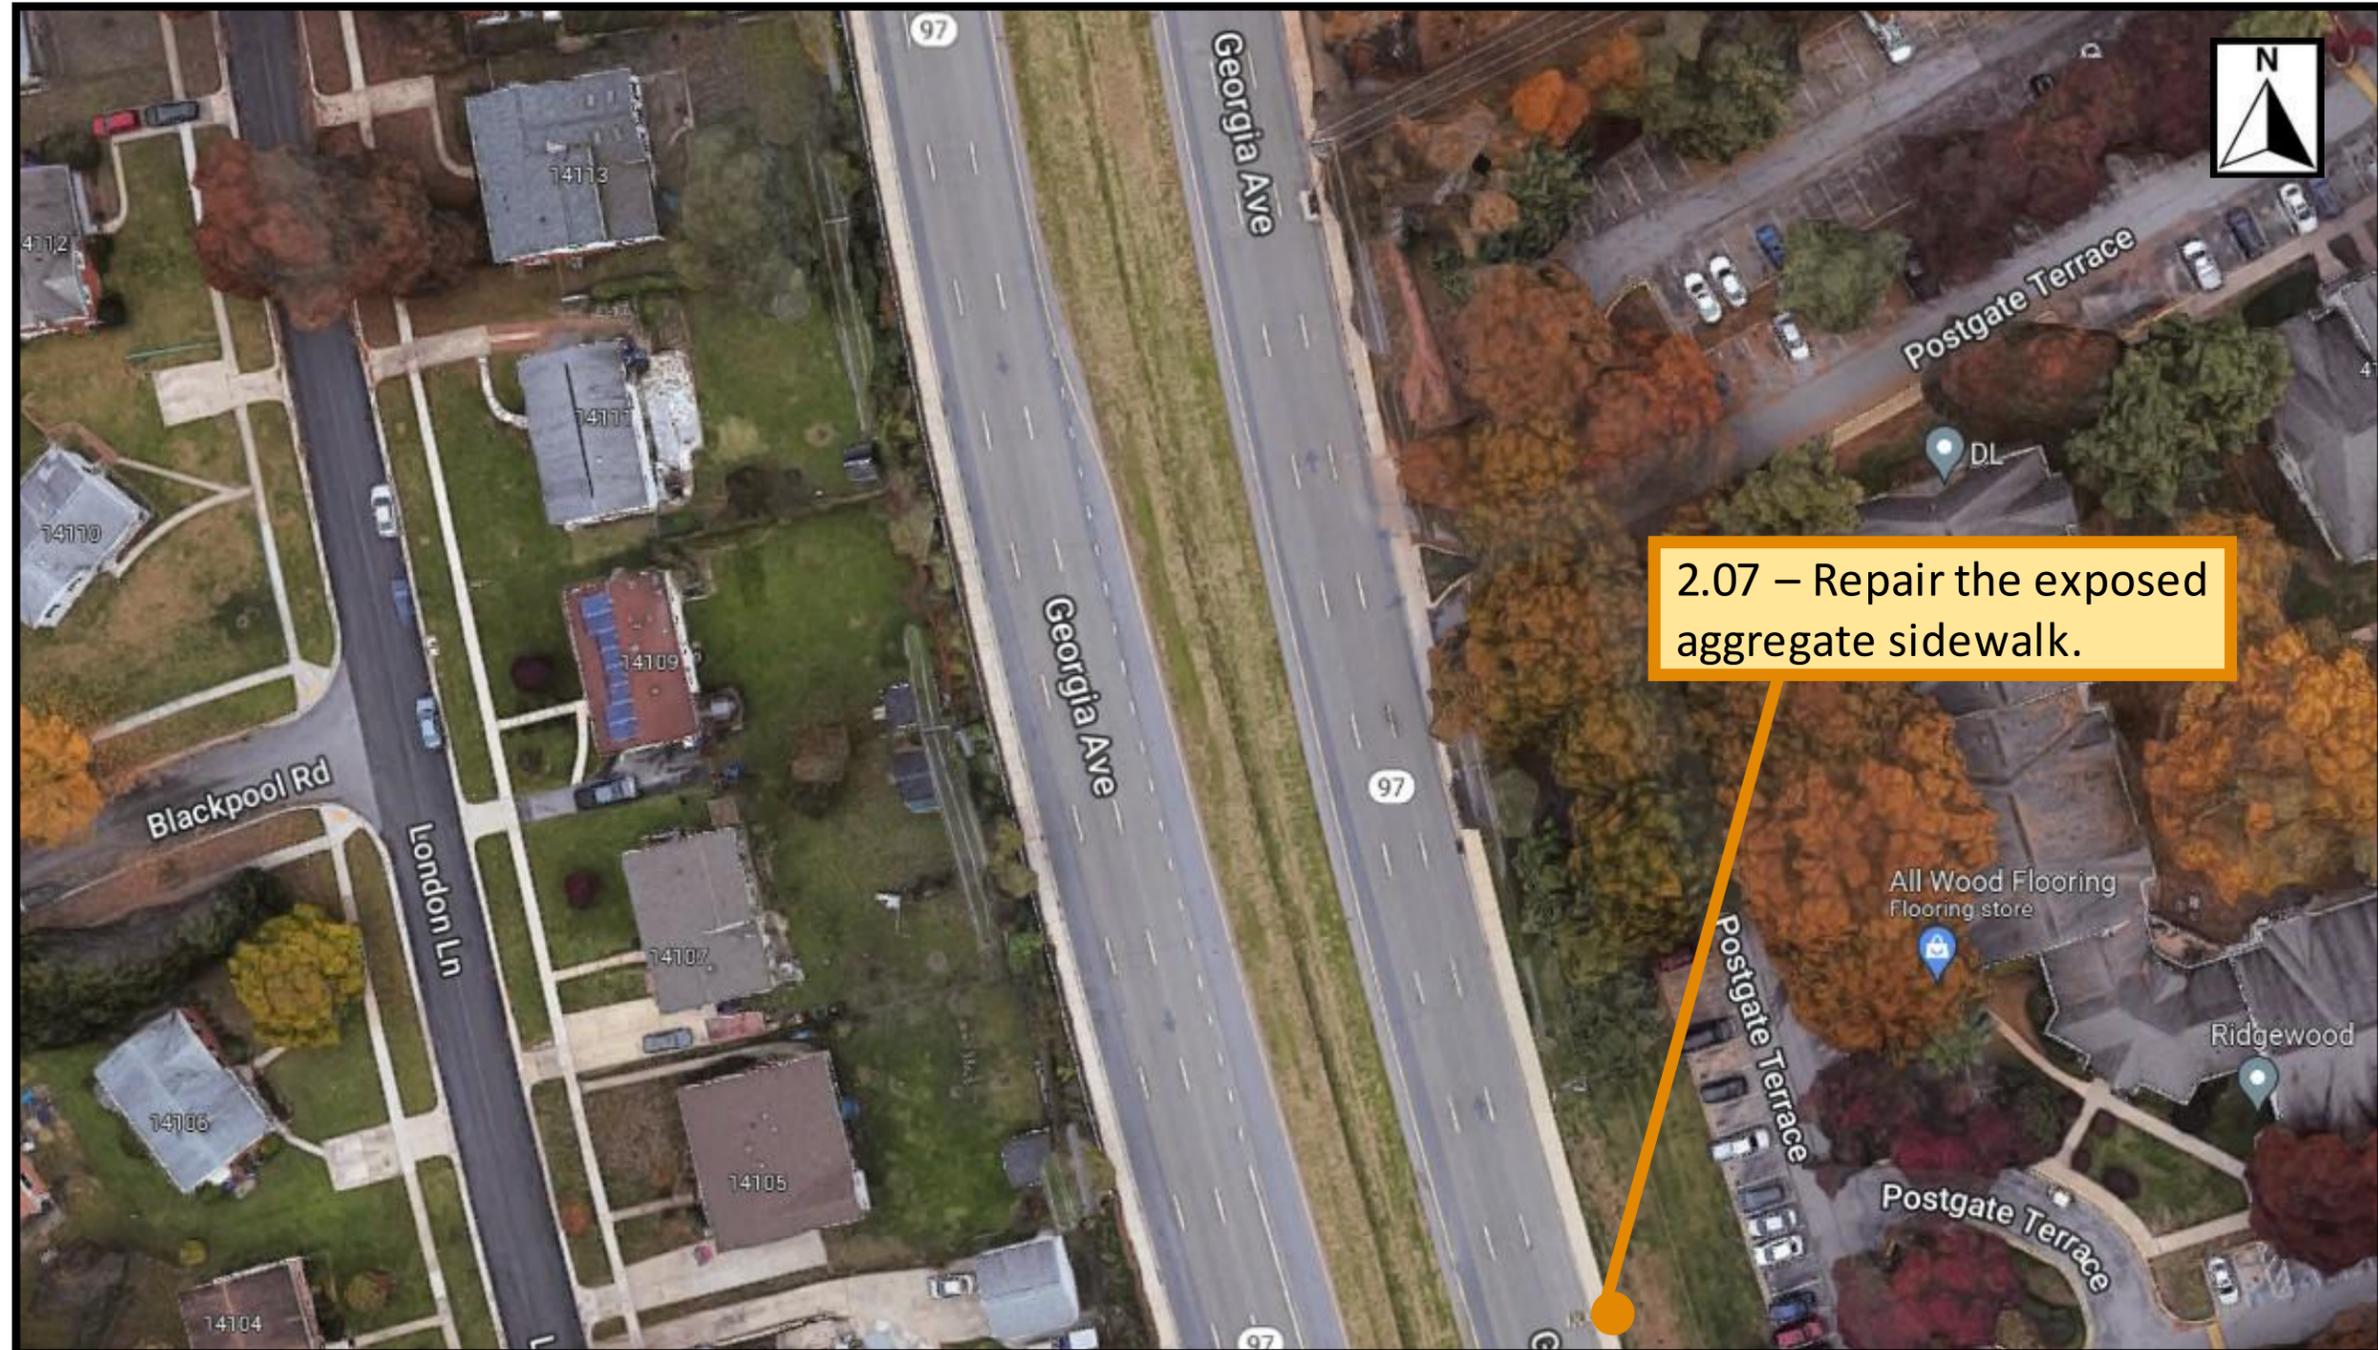
Figure 2: MCDOT – Specific Recommendations: MD 97 (Georgia Avenue) between Bel Pre Road and Heathfield Road

2.07	Maintenance. Sidewalk damaged.	Repair the exposed aggregate sidewalk along NB MD 97, just north of Postgate Terrace.	0 – 6 months
Location 3: MD 97 (Georgia Avenue) at Heathfield Road/Postgate Terrace – Signalized Intersection

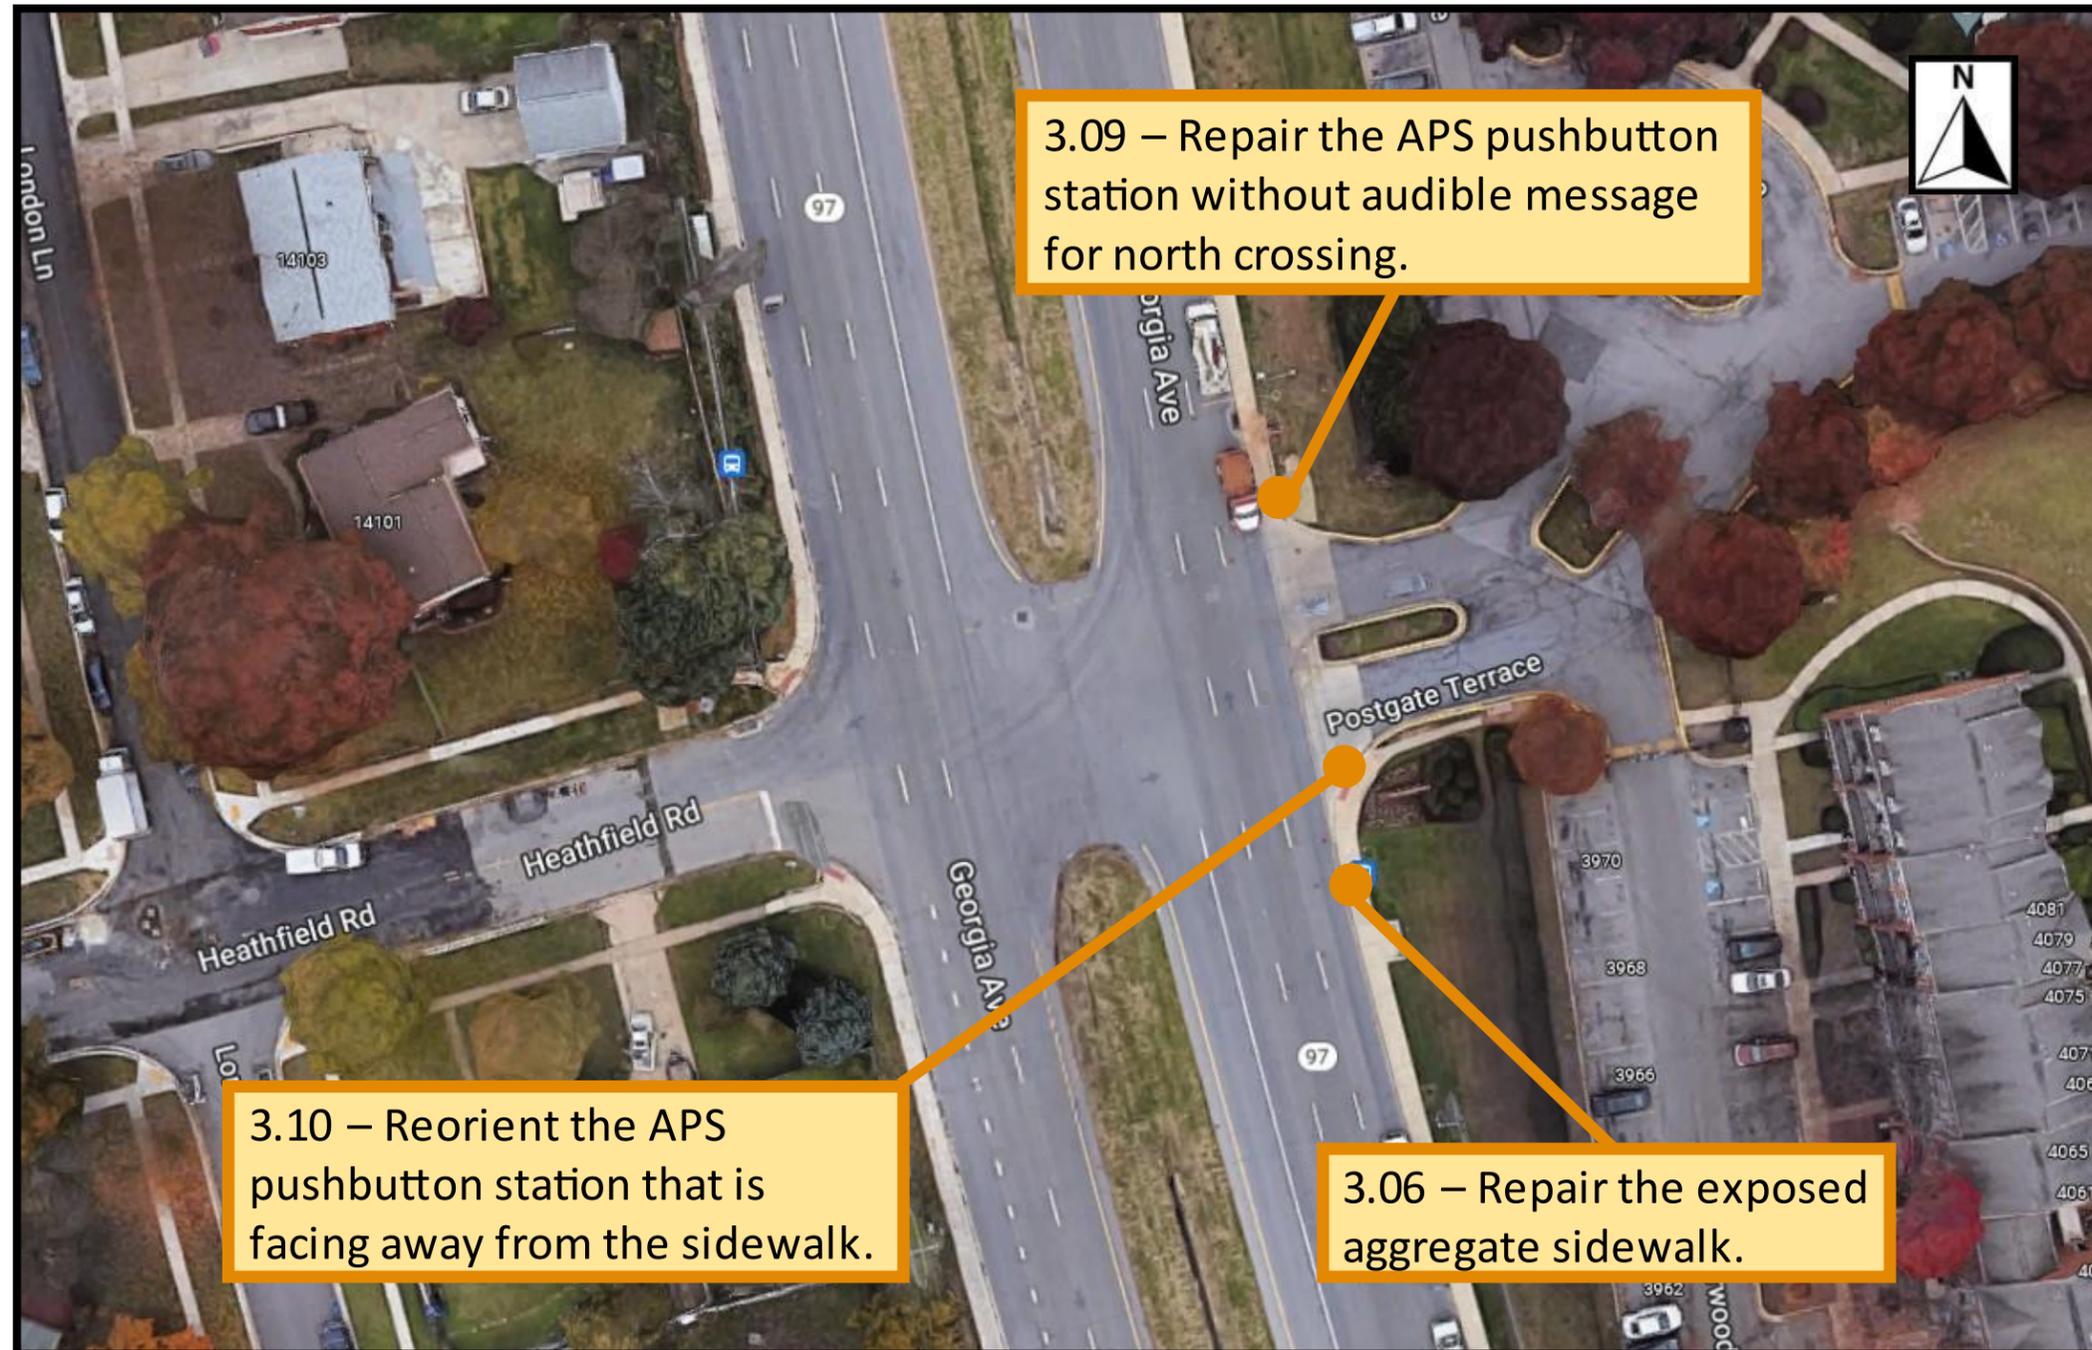
Figure 3: MCDOT – Specific Recommendations: MD 97 (Georgia Avenue) at Heathfield Road/Postgate Terrace

3.06	Maintenance. Sidewalk surface is chipping.	Repair the exposed aggregate sidewalk near NB bus stop (WMATA ID 2001361).	0 – 12 months
3.09	Maintenance. Audible message malfunction.	Repair the APS pushbutton station without audible message for north crossing (NE quadrant).	0 – 6 months

3.10	Maintenance. MDOT SHA APS design guidance non-compliance.	Reorient the APS pushbutton station that is facing away from the sidewalk in the SE corner of the intersection.	0 – 6 months
Location 4: MD 97 (Georgia Avenue) between Heathfield Road and the Home Depot Driveway – Road Segment

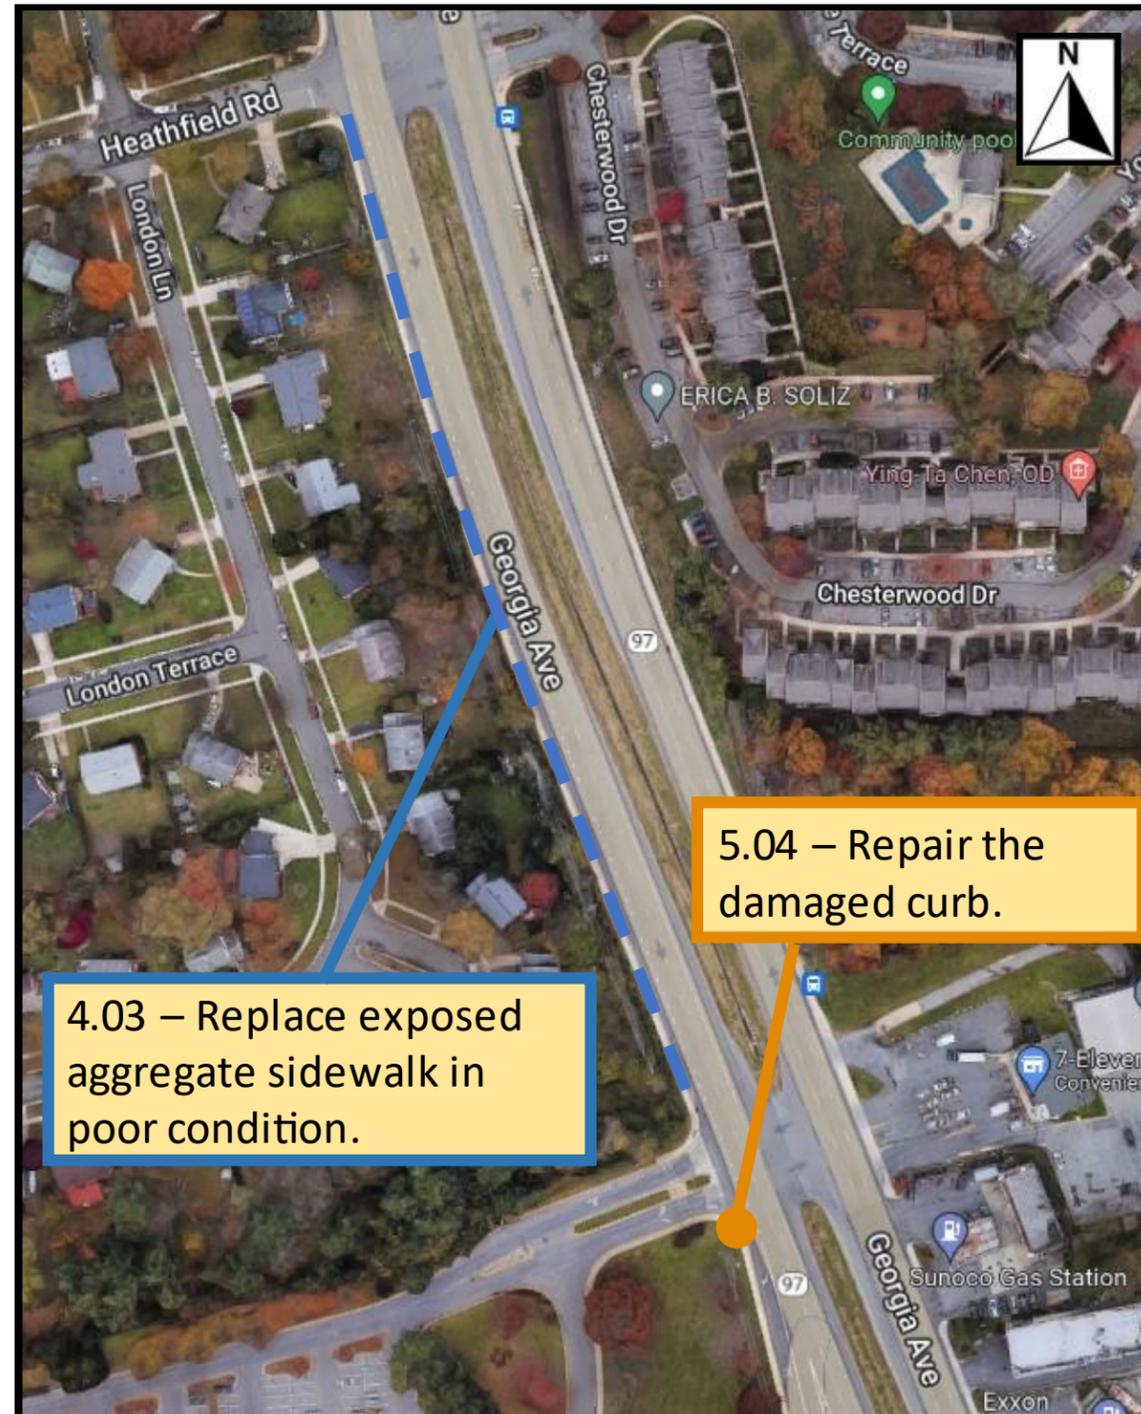
Figure 4: MCDOT – Specific Recommendations: MD 97 (Georgia Avenue) between Heathfield Road and the Home Depot Driveway

4.03	Maintenance. Sidewalk surface is chipping.	Replace exposed aggregate sidewalk in poor condition along the SB direction of MD 97 – approximately 800 linear feet.	6 – 12 months
Location 5: MD 97 (Georgia Avenue) at Home Depot Driveway

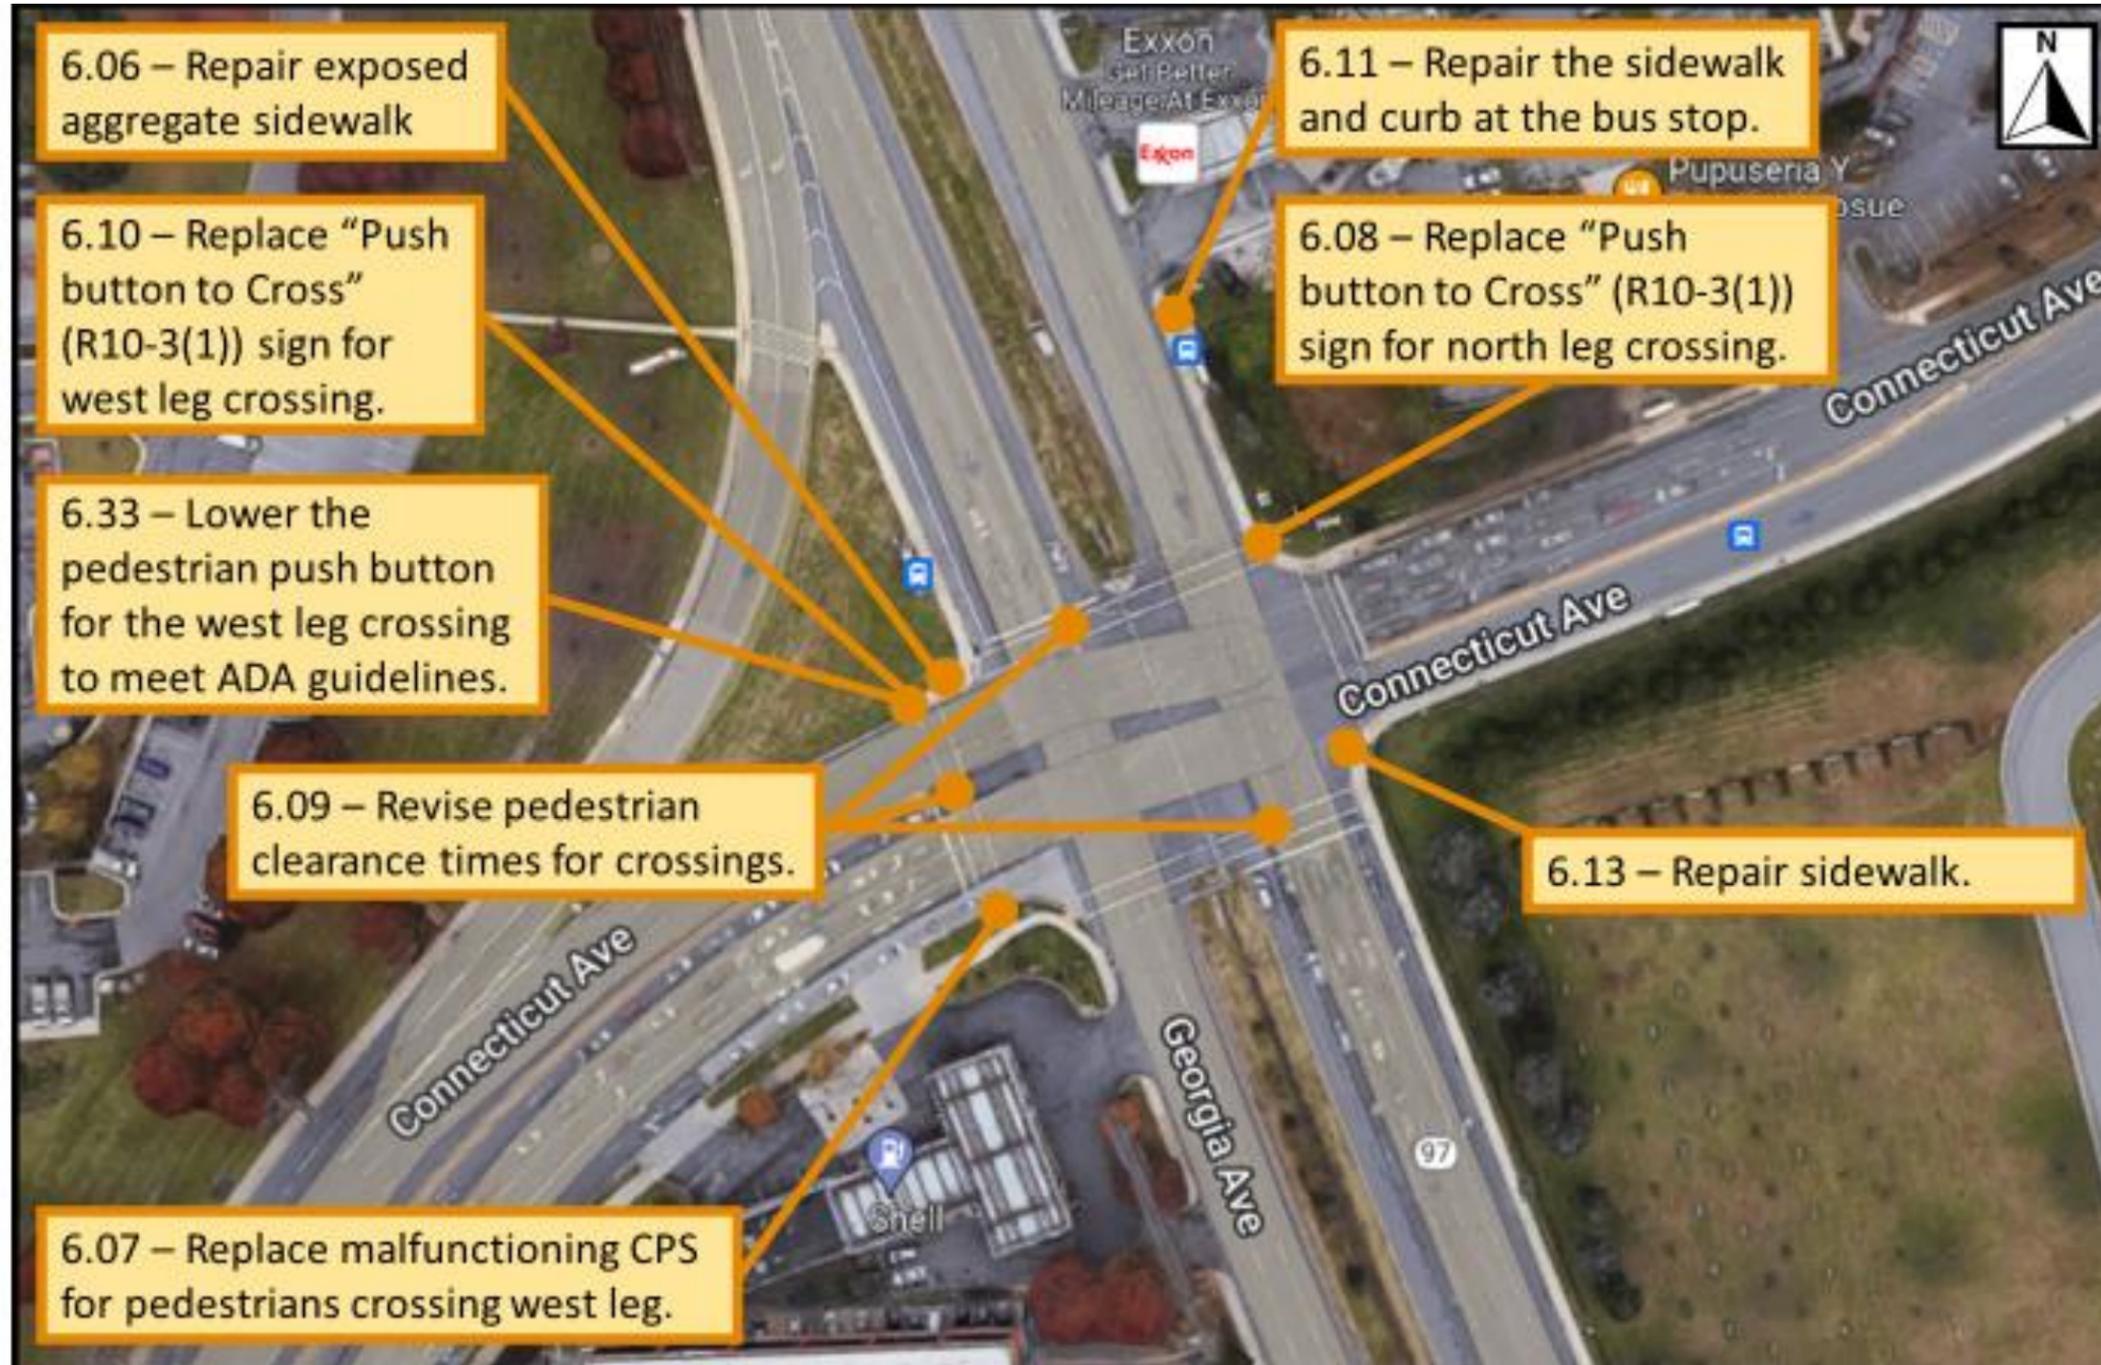
Figure 5: MCDOT – Specific Recommendations: MD 97 (Georgia Avenue) at MD 185 (Connecticut Avenue)

6.06	Maintenance. Sidewalk surface is chipping.	Repair exposed aggregate sidewalk in the NW corner.	0 – 12 months
6.07	Maintenance. CPS is malfunctioning, no countdown.	Replace malfunctioning CPS in the SW quadrant for pedestrians crossing the west leg of the intersection (crossing MD 185).	0 – 6 months

6.08	Maintenance. Missing pedestrian information sign.	Replace "Push button to Cross" (R10-3(1)) sign for crossing the north leg (crossing MD 97) in the NE corner.	0 – 6 months

6.09	Ped-Vehicle Conflicts. Pedestrian clearance times are shorter than required for 3.5 ft/sec walking speed based on crossing lengths.	Revise pedestrian clearance times for crossing the west MD 185, north MD 97, and south MD 97 intersection legs to meet appropriate flashing don't walk time for 3.5 ft/sec walking speed.	0 – 6 months

6.10	Maintenance. Pedestrian information sign does not list roadway name.	Replace "Push button to Cross" (R10-3(1)) sign for crossing the west leg (crossing MD 185) in the NW corner.	0 – 6 months

6.11	Maintenance. Sidewalk in poor condition.	Repair the sidewalk and curb at the bus stop (WMATA ID 2000890) in the NE corner.	0 – 6 months
6.13	Maintenance. Sidewalk and curb damaged.	Repair sidewalk in the southeast corner.	0 – 12 months

6.33	Ped Facilities. The pedestrian push button in the NW corner of the intersection for the west leg crosswalk (crossing MD 185) is mounted higher than the ADA max height of 42".	Lower the pedestrian push button in the NW corner of the intersection for the west leg (crossing MD 185), so that it is mounted according to ADA guidelines.	0 – 6 months
Location 7: MD 97 (Georgia Avenue) between MD 185 (Connecticut Avenue) and Aspen Hill Road – Road Segment

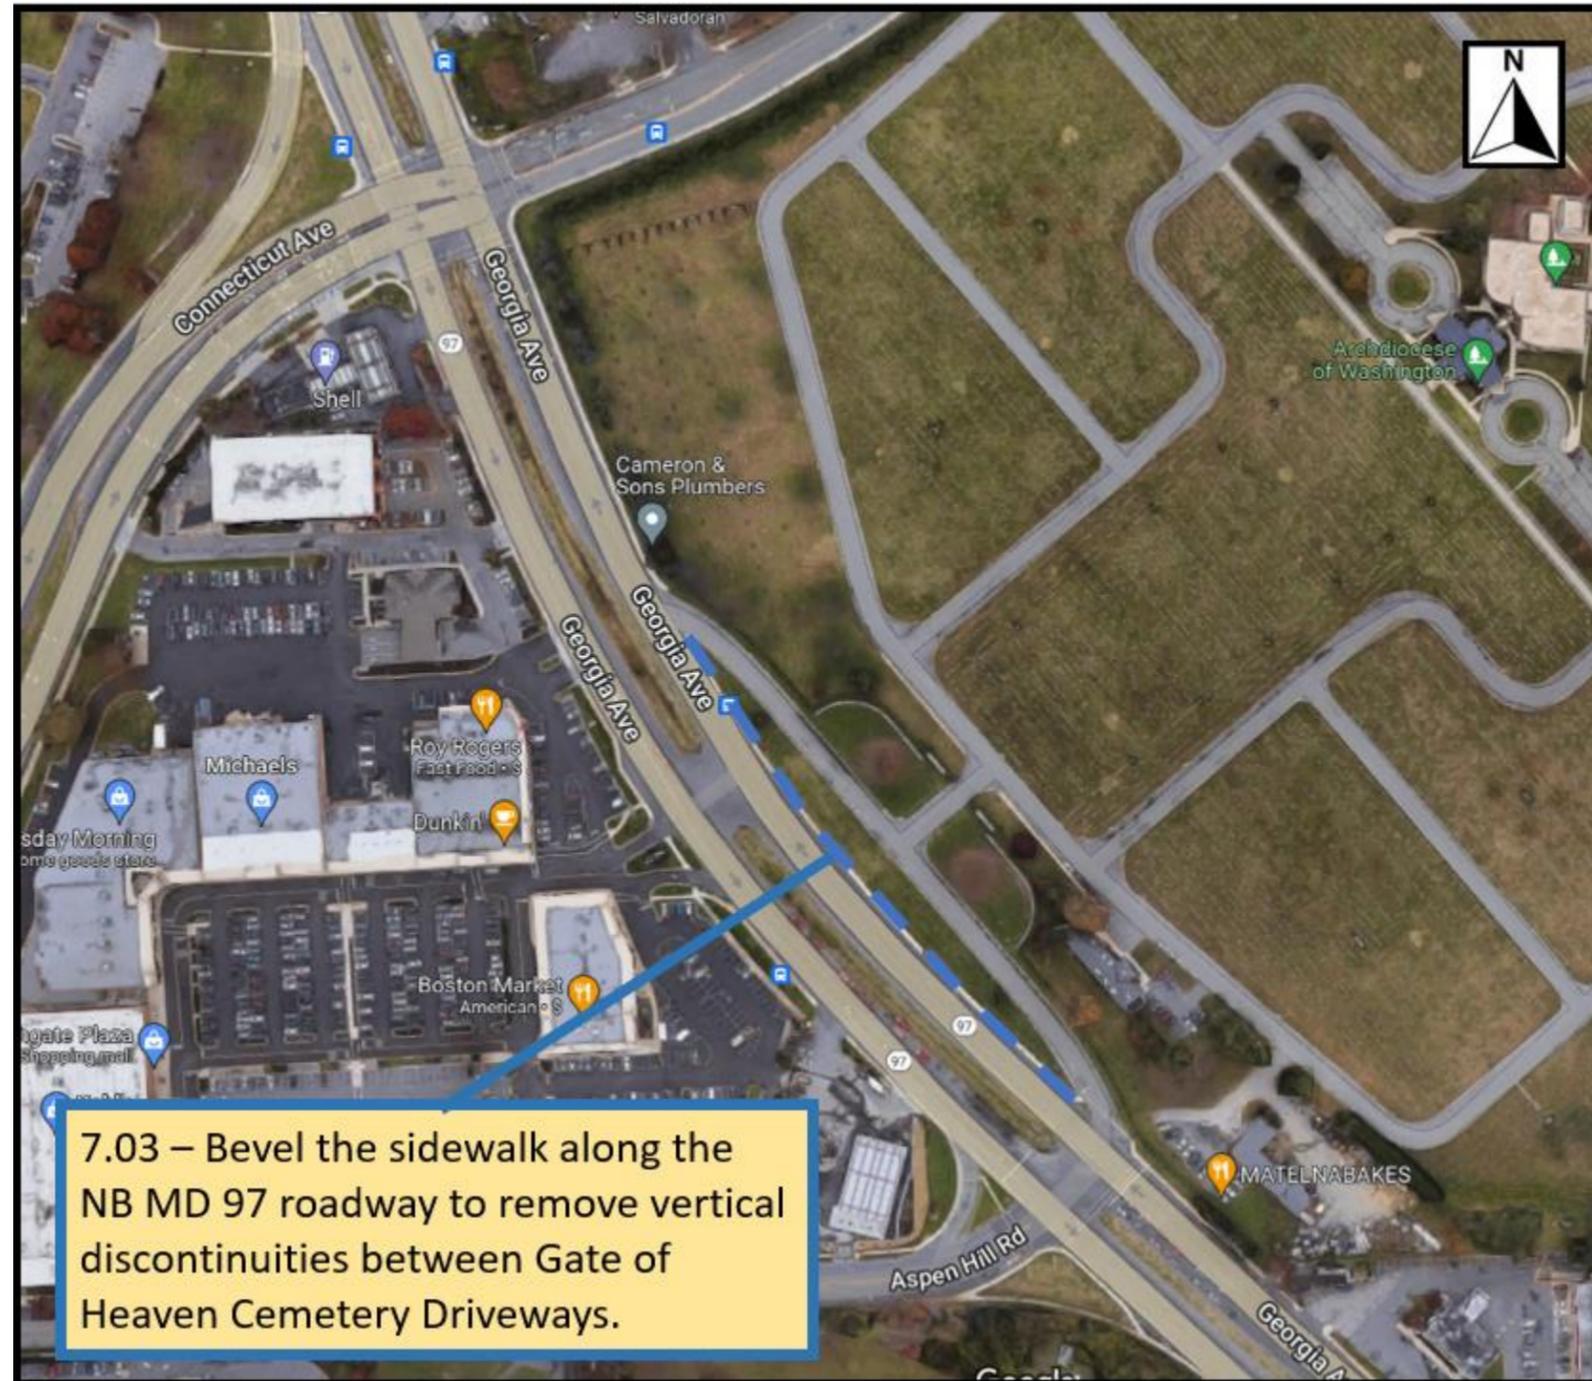
Figure 6: MCDOT – Specific Recommendations: MD 97 (Georgia Avenue) between MD 185 (Connecticut Avenue) and Aspen Hill Road

7.03	Maintenance. Sidewalk vertical discontinuities.	Bevel the sidewalk along the NB MD 97 roadway to remove vertical discontinuities between Gate of Heaven Cemetery driveways.	0 – 12 months
Location 8: MD 97 (Georgia Avenue) at Aspen Hill Road – Signalized Intersection

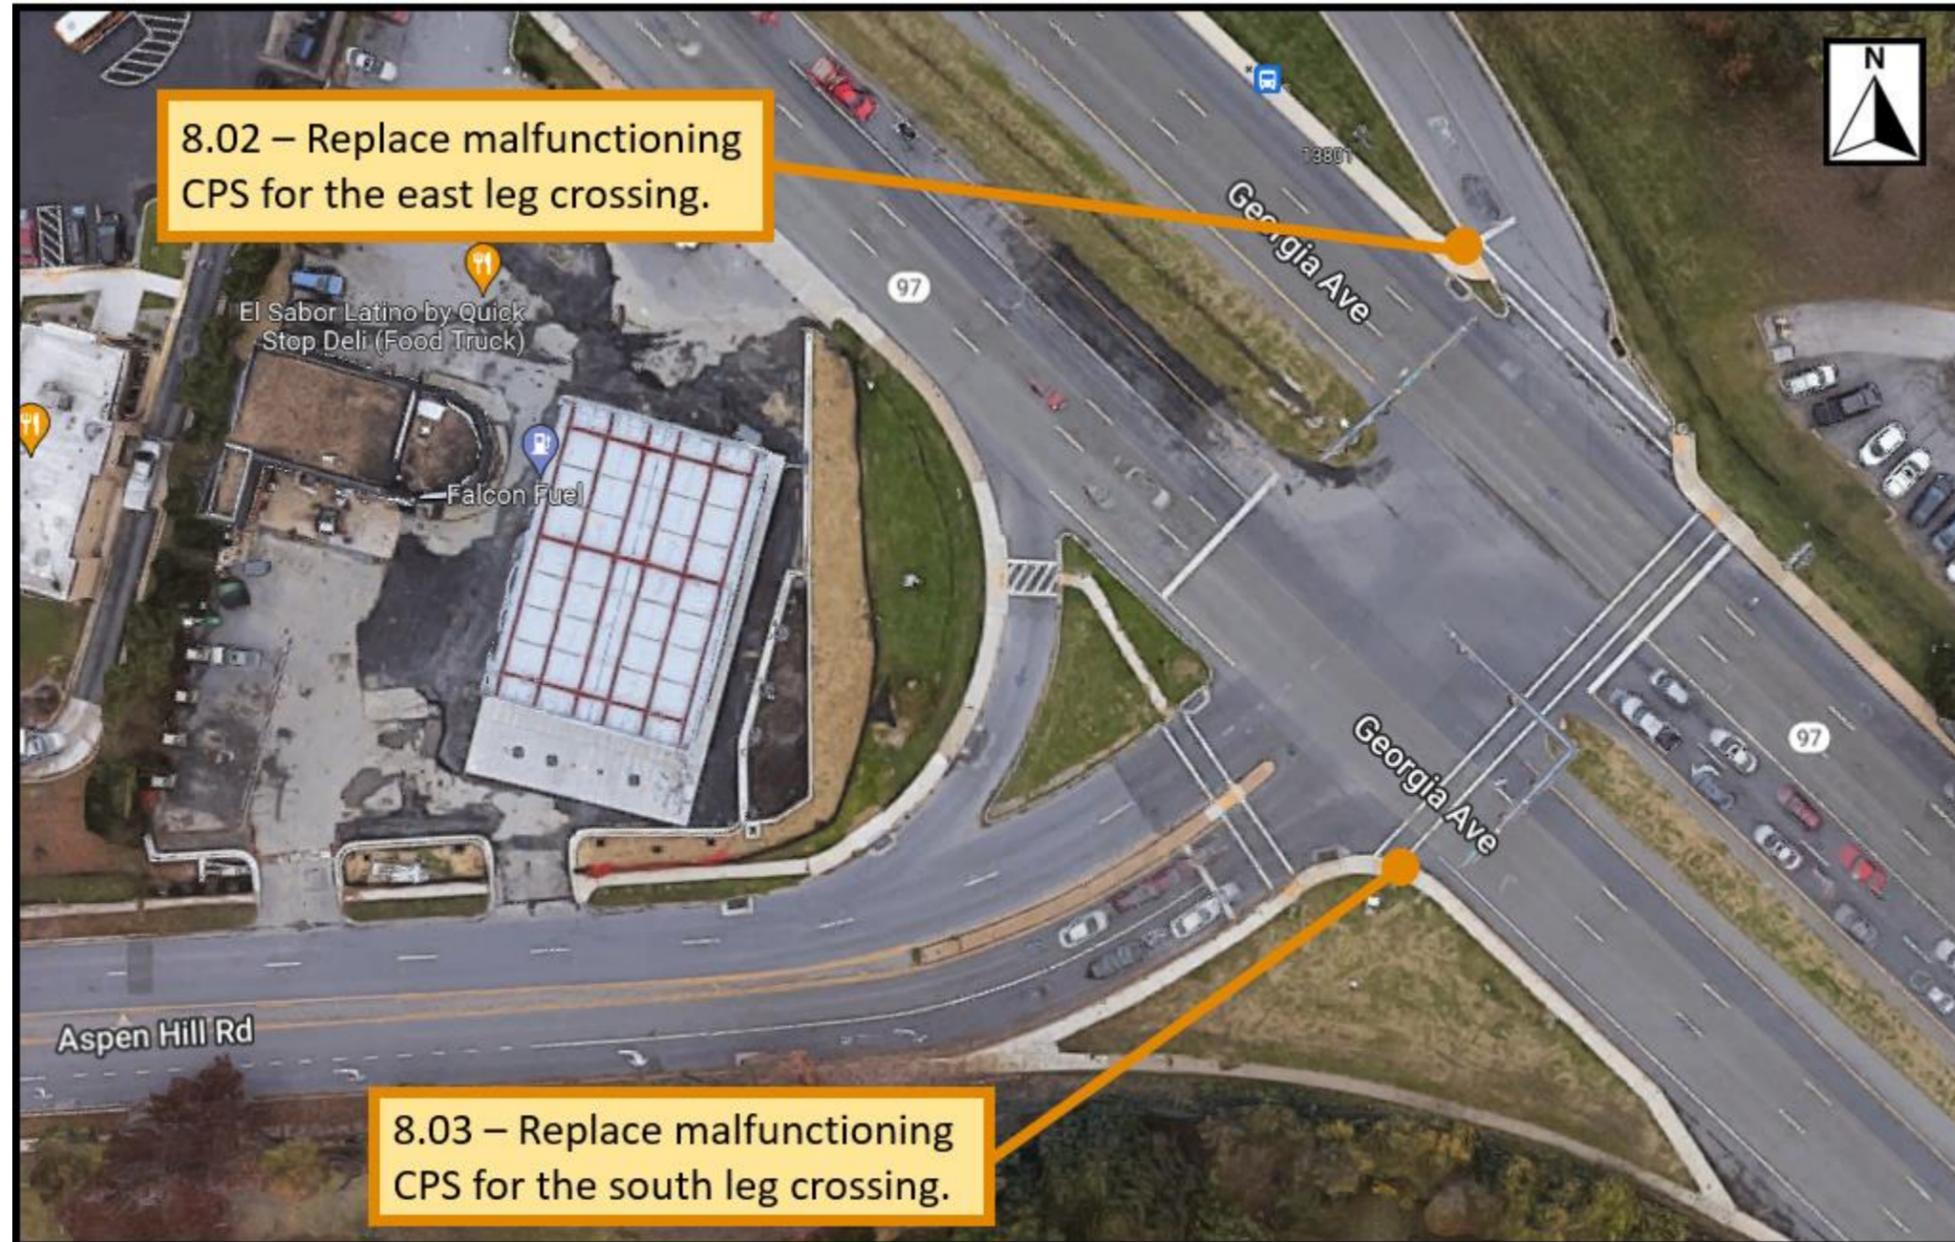
Figure 7: MCDOT – Specific Recommendations: MD 97 (Georgia Avenue) at Aspen Hill Road

8.02	Maintenance. CPS malfunction.	Replace malfunctioning CPS for the east leg crossing (WALK does not display on NE corner) (for crossing Gate of Heaven Cemetery driveway).	0 – 6 months

8.03	Maintenance. CPS malfunction.	Replace malfunctioning CPS for the south leg crossing (countdown does not display on SW corner) (for crossing MD 97).	0 – 6 months
Location 11: MD 97 (Georgia Avenue) between Wendy Lane and Ralph Road – Road Segment

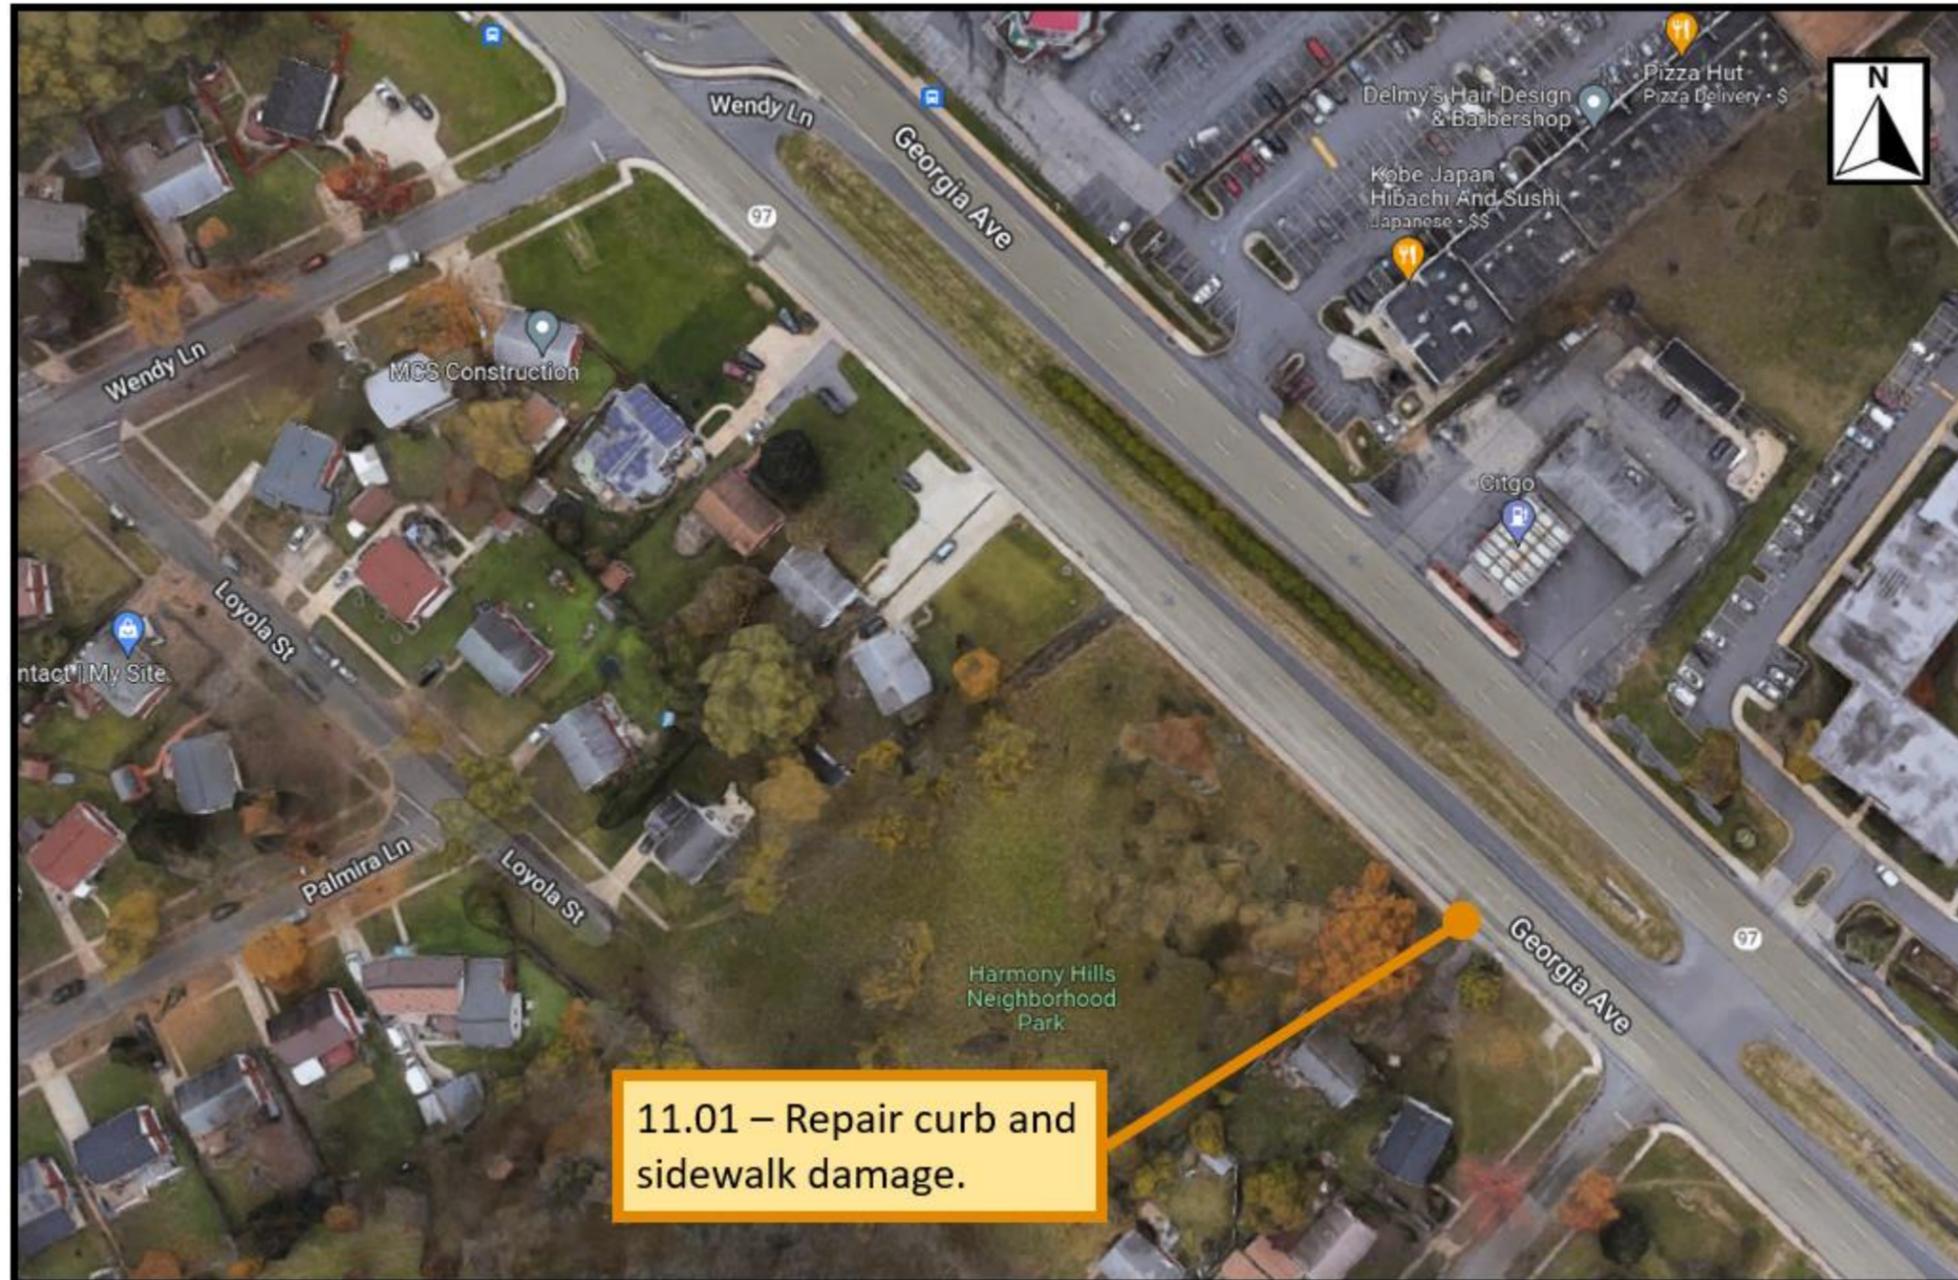
Figure 8: MCDOT – Specific Recommendations: MD 97 (Georgia Avenue) between Wendy Lane and Ralph Road

11.01	Maintenance. Sidewalk damage from utility work.	Repair curb and sidewalk damage along SB MD 97 near fire hydrant approximately 120 feet north of Ralph Road.	0 – 6 months
Location 13: MD 97 (Georgia Avenue) between Ralph Road and Hewitt Avenue – Road Segment
